# NH Department of Environmental Services Dam Bureau

Chuck Corliss  
Dam Safety Engineer

# Presentation Goal

Determine the amount of downstream incremental flow along the Mad River that was associated with the operation of the flashboards at Snow's Pond Dam during Tropical Storm Irene.

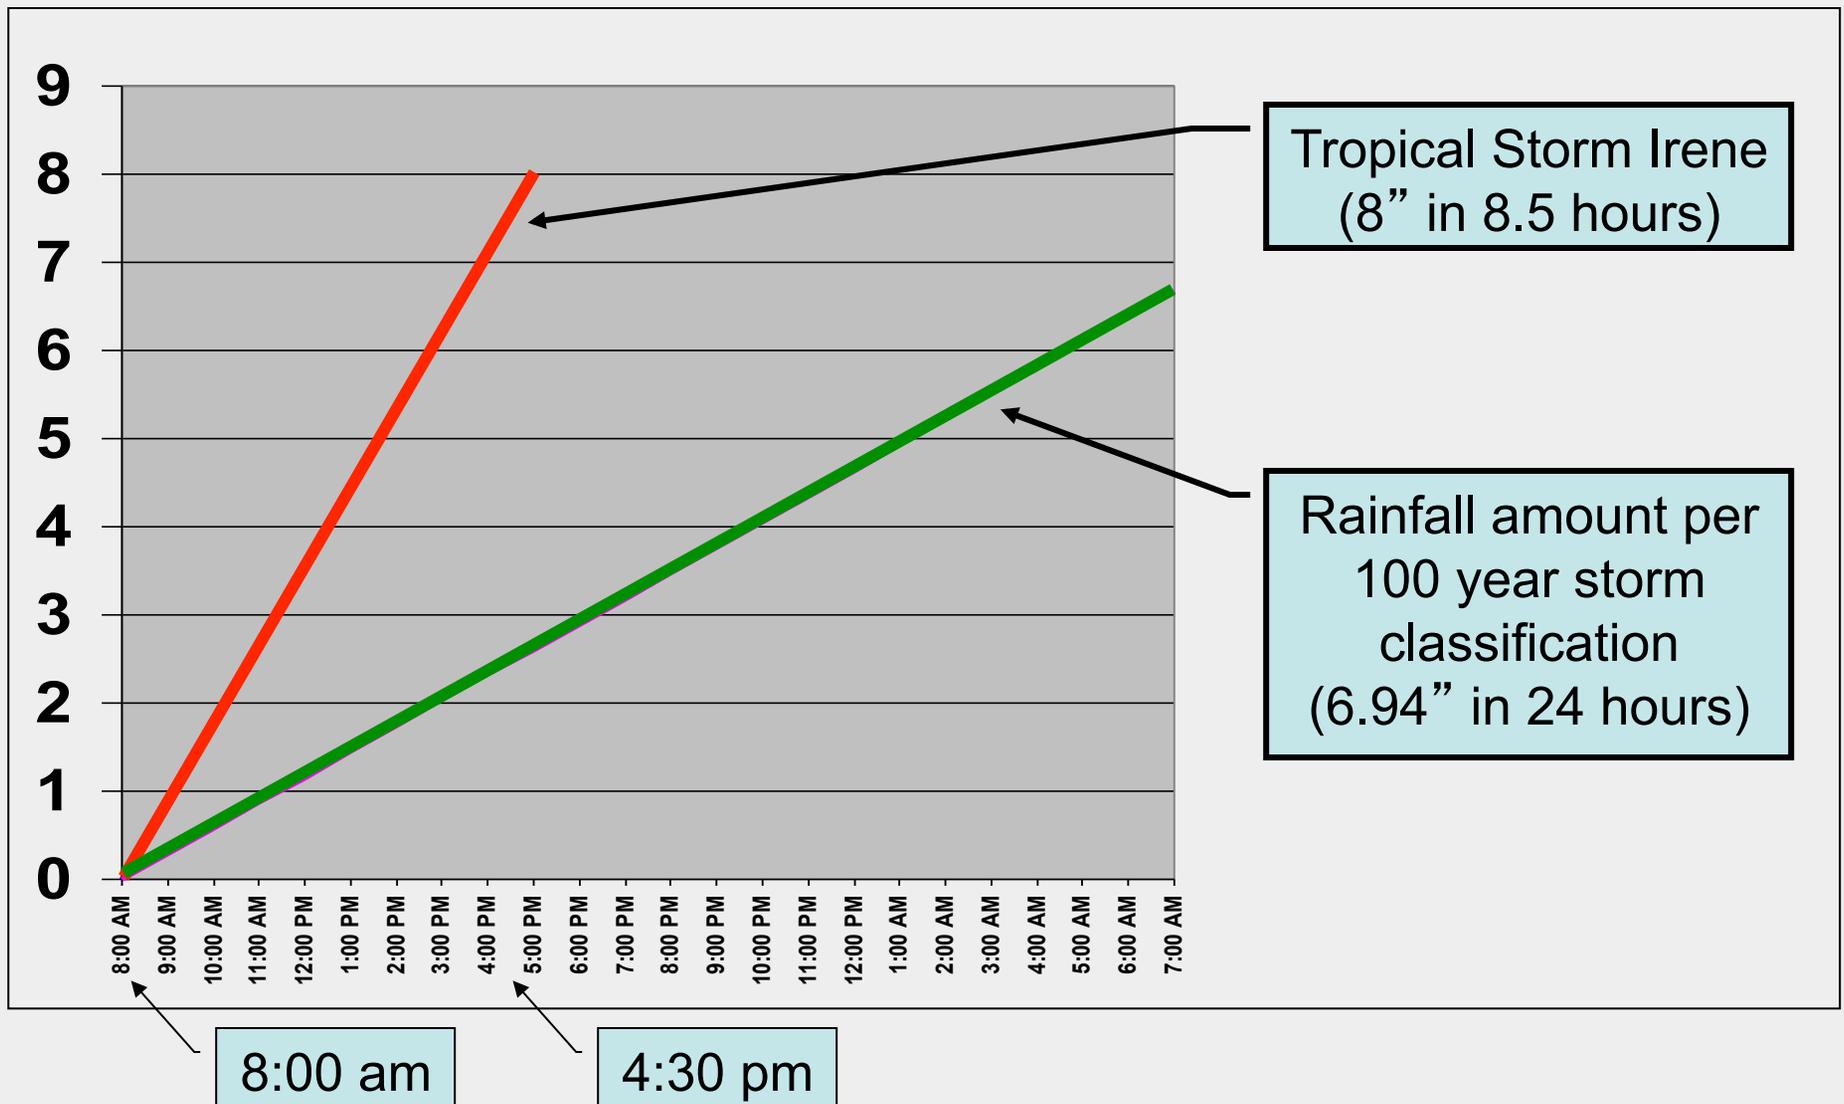
# Tropical Storm Irene Rainfall

- Month of August 2011, rainfall amounts:  
6.55" prior to Tropical Storm Irene  
(4.42" normal average for month of August).

3.50" of this total occurred the Sunday  
prior to Tropical Storm Irene.

Note: Ground had a significant level of saturation  
prior to August 28

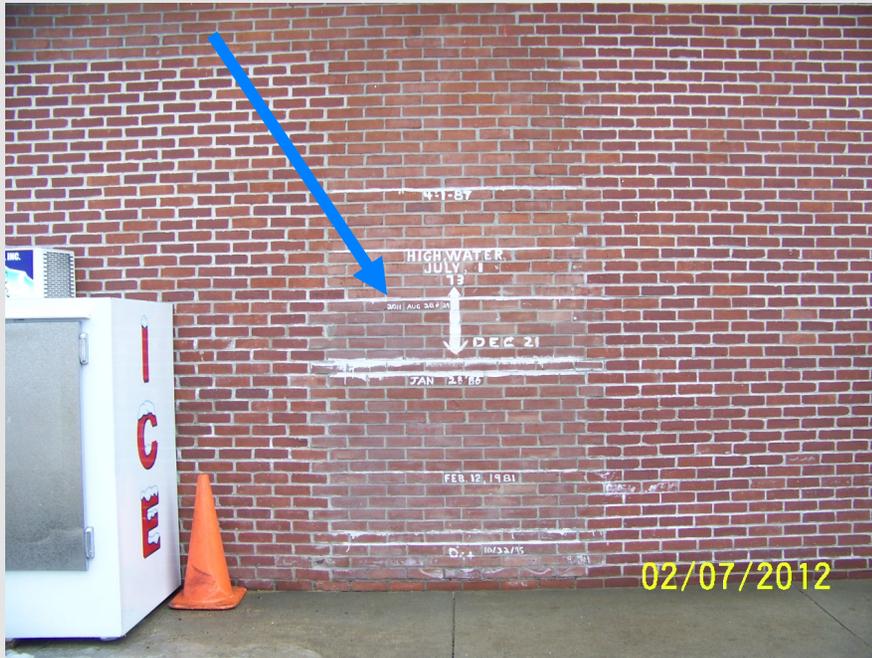
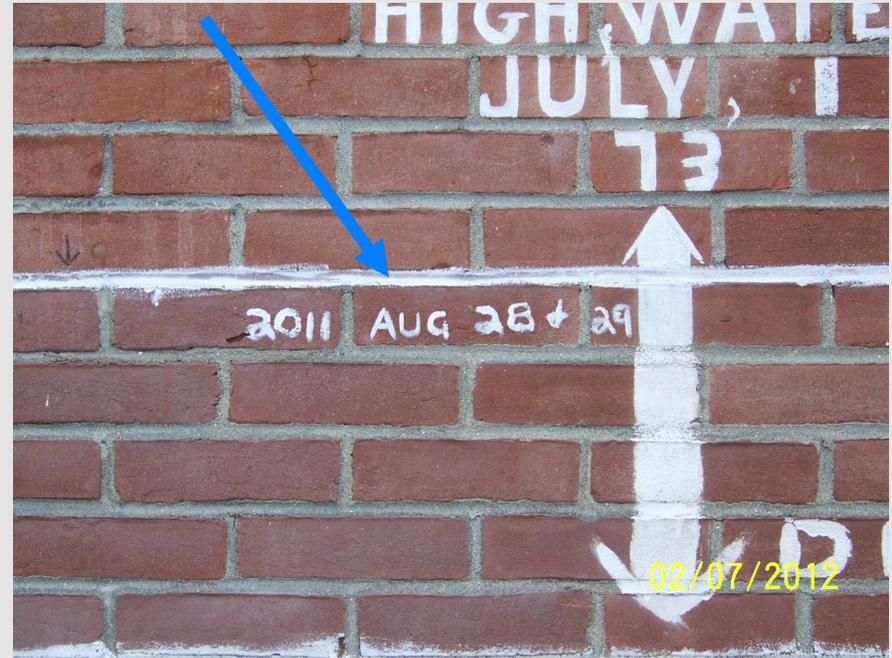
# Service Station, Downtown Plymouth

July 1, 1973

October 22, 1975

February 12, 1981

January 28, 1986

August 28, 2011

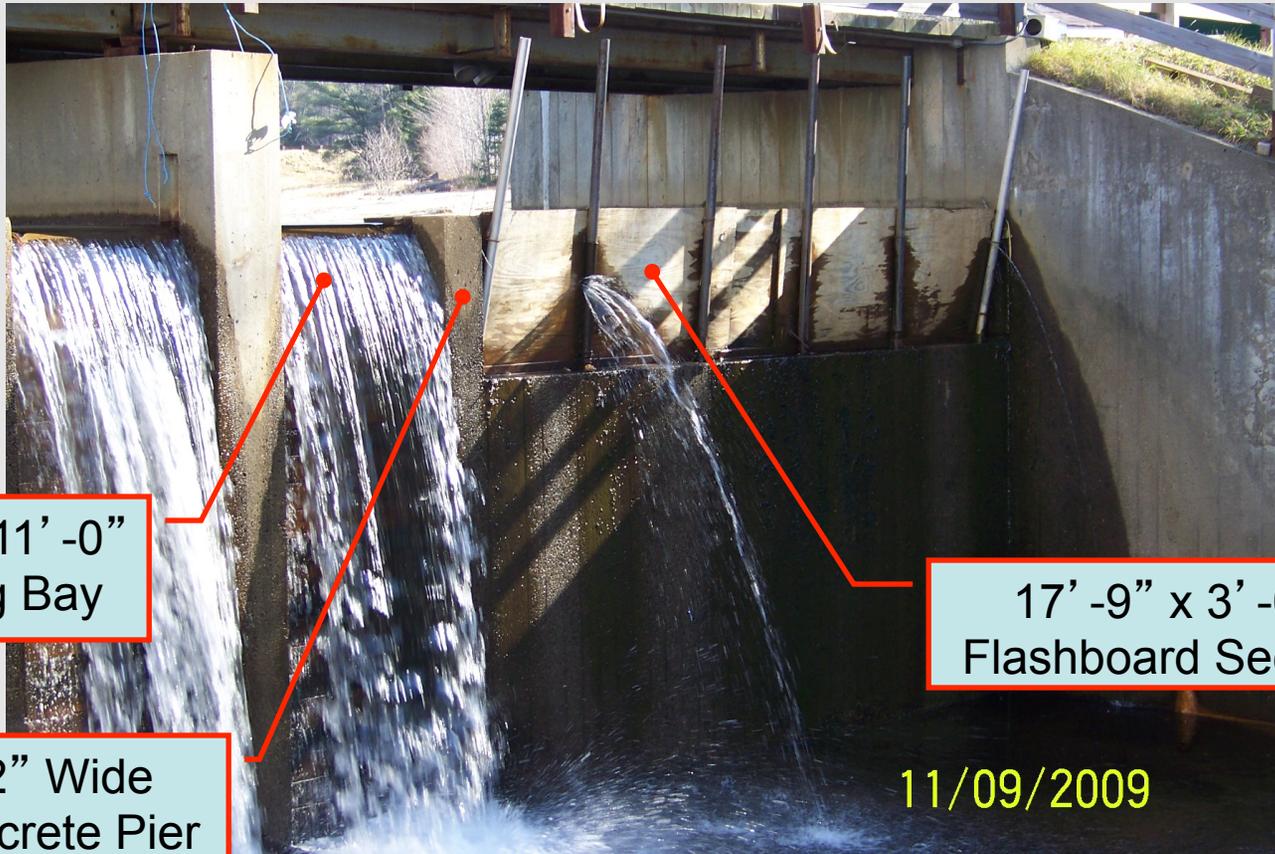
## Stoplog and Flashboard Systems

4' -0" x 11' -0"  
Stoplog Bay

12" Wide  
Concrete Pier

17' -9" x 3' -0"  
Flashboard Section

- General Information:
  - Normal pool elevation = 1,476.0 (top of flashboards).
  - Pond surface area = 4.9 acres, Say 5.0 acres.
  - Top of dam elevation = 1,480.0.
  - Stoplogs placed to elevation = 1,475.75 (Normal day).
- Saturday August 27, 2011:
  - 5:00 pm, 2 stoplogs removed to elevation 1,474.79.
  - 7:00 pm, 3 more stoplogs removed to elevation 1,473.35.
  - Noted in Owner' s Operation, Maintenance and Response Plan (OMR).
- Sunday August 28, 2011, Tropical Storm Irene:
  - 10:00 am Pond Level at elevation 1,473.35, top of stoplogs.
  - 1:30 Flashboards bent over approximately 30 degrees, pond elevation 1477.00.
  - 2:00 +/-, Flashboards operated with water level 25" below top of dam, elevation 1,477.92.
  - Storage from base of flashboards to height of pond during Tropical Storm Irene, at 23" above flashboards = 24.9 acre-ft.

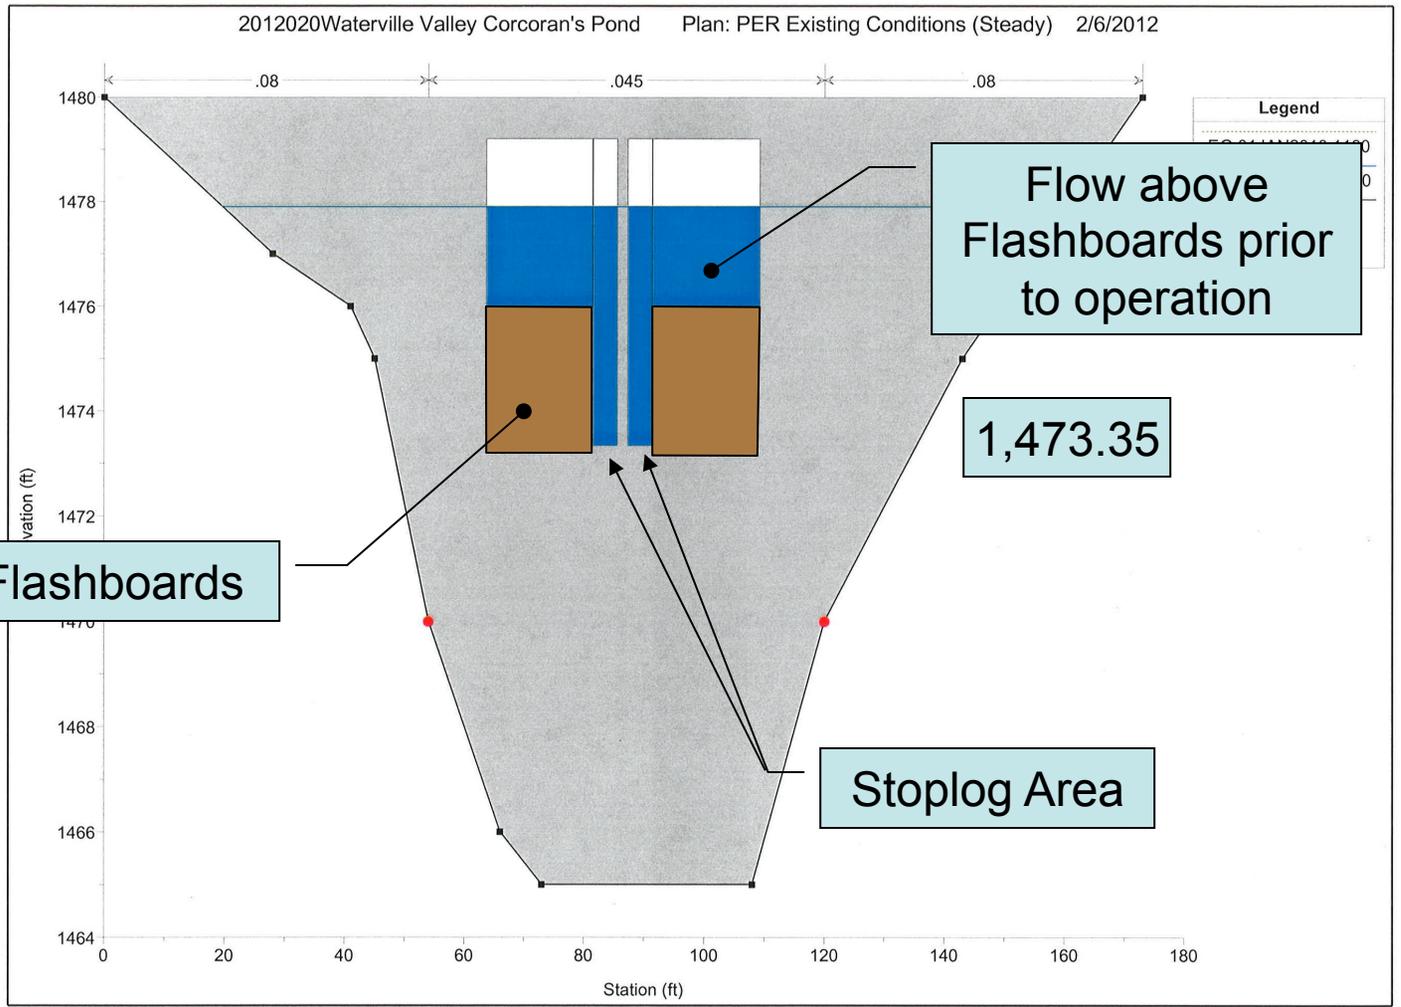
# Snow's Pond Dam Outlet Cross Section

1,480.00

1,477.90

1,476.00

1,473.00

- General Information:
  - With computer software, HydroCAD 10.0, HEC RAS 4.0 and Excel spreadsheets models computed and compared pre and post flashboard flows at the dam and downstream cross pipes.
- Calculations/Analysis:
  - Pre flashboard operation; Flow = **591 cfs** at dam (cubic feet per second).
  - Post flashboard operation; Flow = **1,564 cfs** at dam.
  - Assumed incremental flow due to flashboard operation = **973 cfs**
  - A flow of 1,564 cfs would fill Snow' s Pond in 12 minutes.

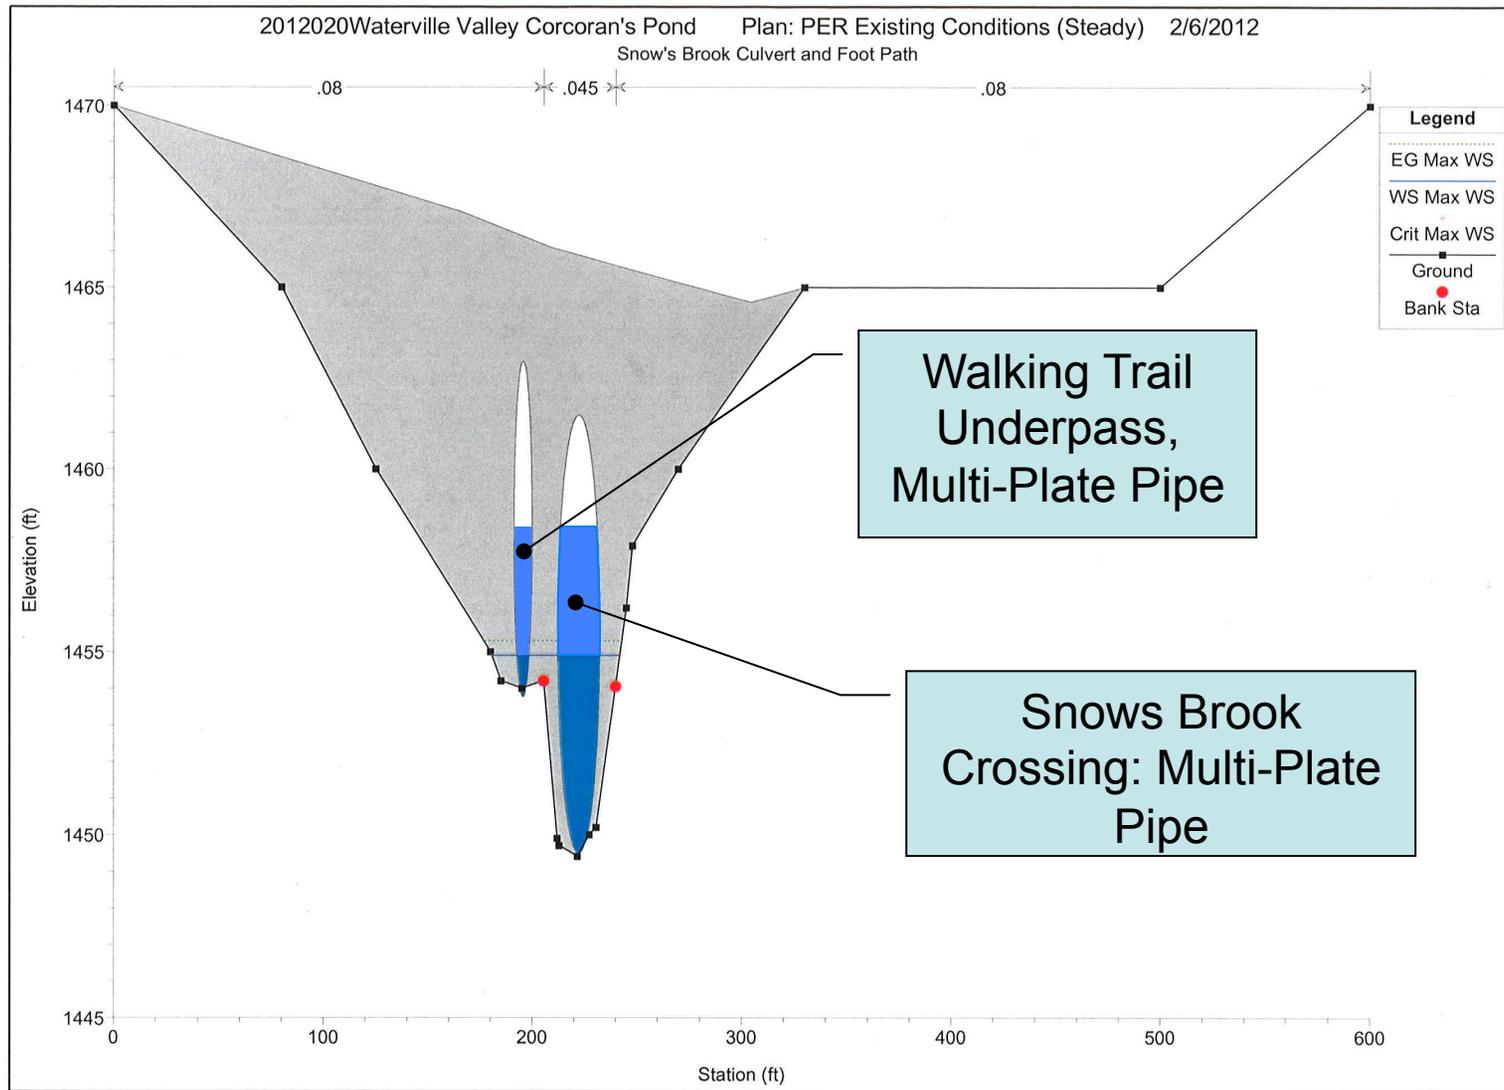
# Snow's Brook Roadway Cross Pipes Cross section

- General Information:
  - With computer software, HydroCAD 10.0, HEC RAS 4.0 and Excel spreadsheets models computed and compared pre and post flashboard flows at the dam and downstream cross pipes.
  - Calculated flow from Snow' s Pond Dam slightly above flow volume calculated at debris line observed at upstream end of cross pipes.
- Calculations/Analysis:
  - Post flashboard operation, calculated flows at Snow' s Brook Roadway = **1,448 cfs**
  - For analysis, used higher number of **1,564 cfs** from Snow' s Pond Dam
  - Assumed incremental flow due to flashboard operation = **973 cfs**

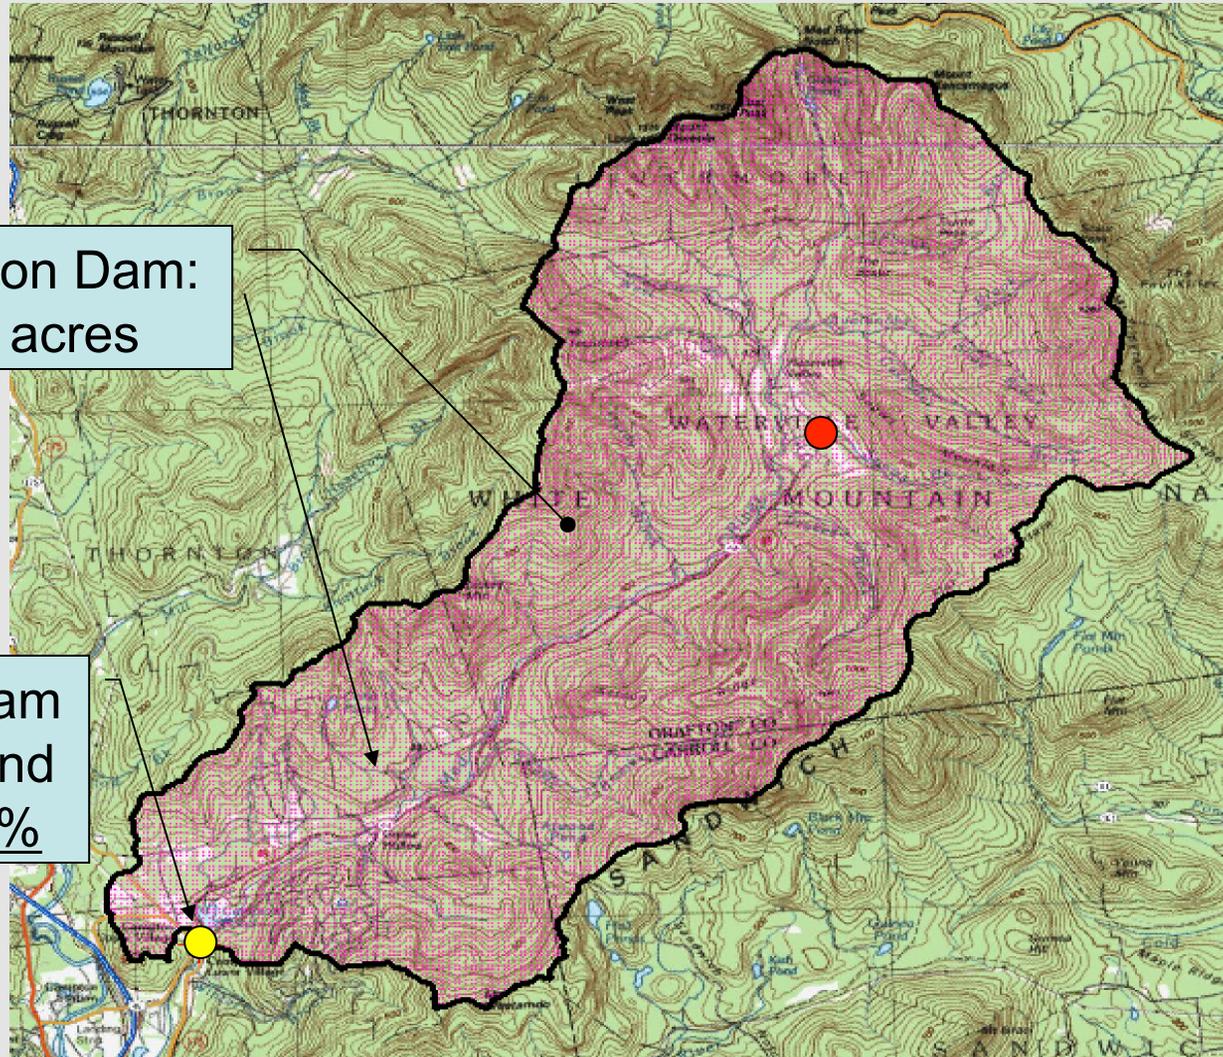
# Campton Dam Watershed

To Campton Dam:  
37,100 acres

Campton Dam  
Average Land  
Slope 25.4%

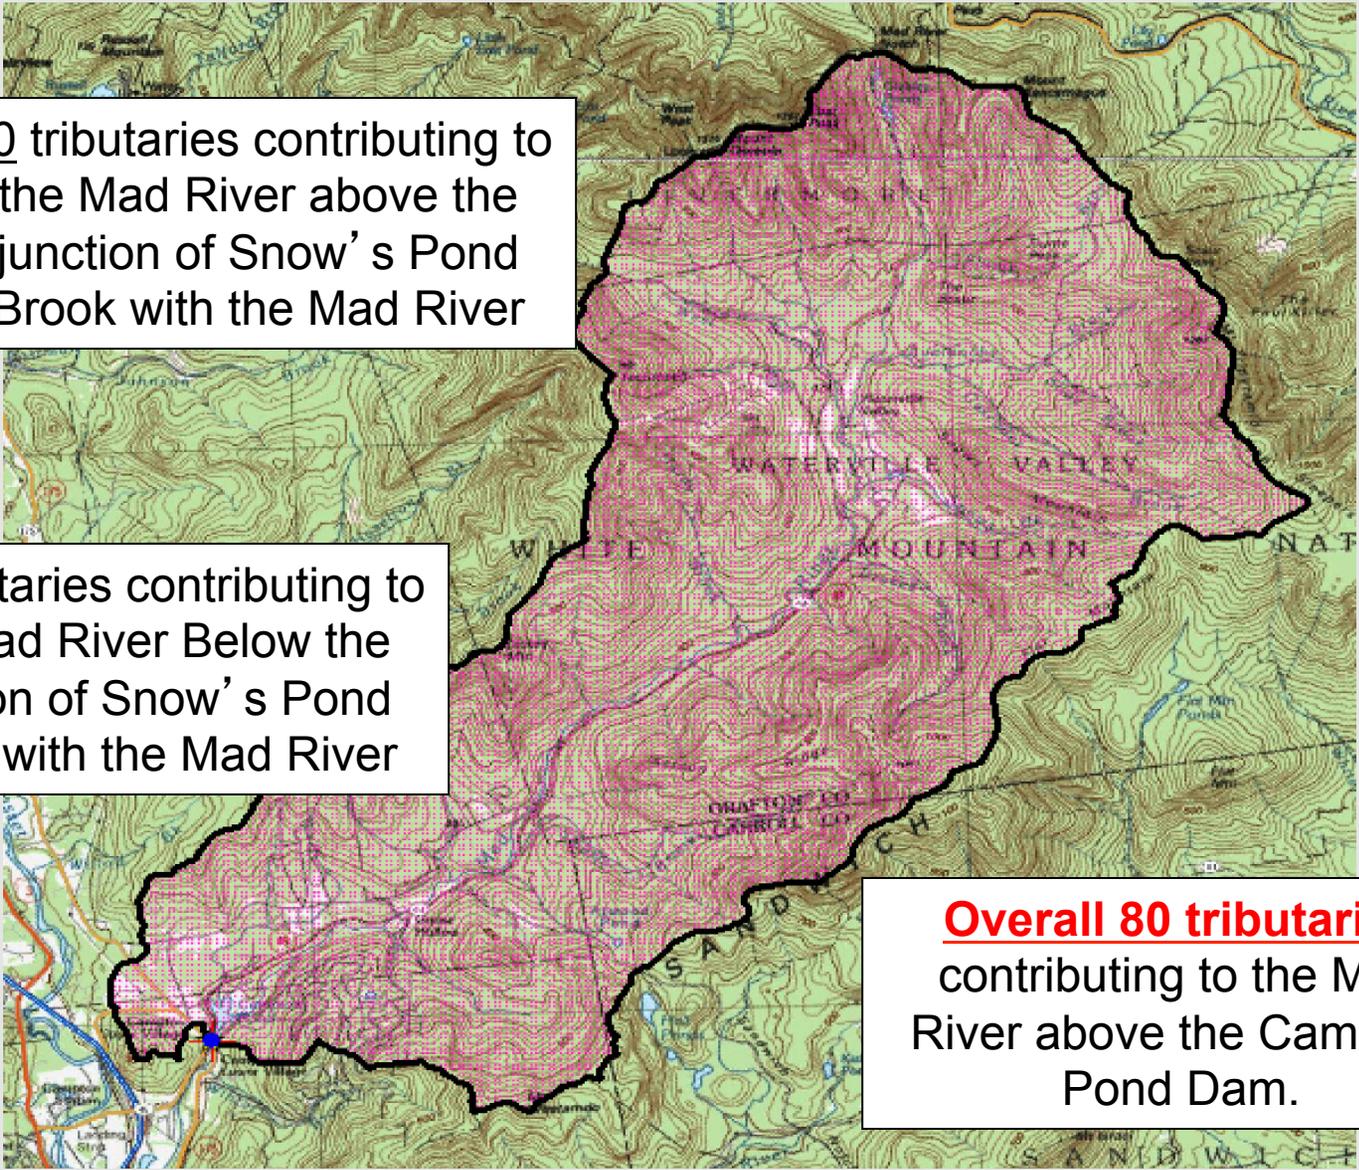
# Contributing Water Sheds - Overall

20 tributaries contributing to the Mad River above the junction of Snow's Pond Brook with the Mad River

60 tributaries contributing to the Mad River Below the junction of Snow's Pond Brook with the Mad River

**Overall 80 tributaries** contributing to the Mad River above the Campton Pond Dam.

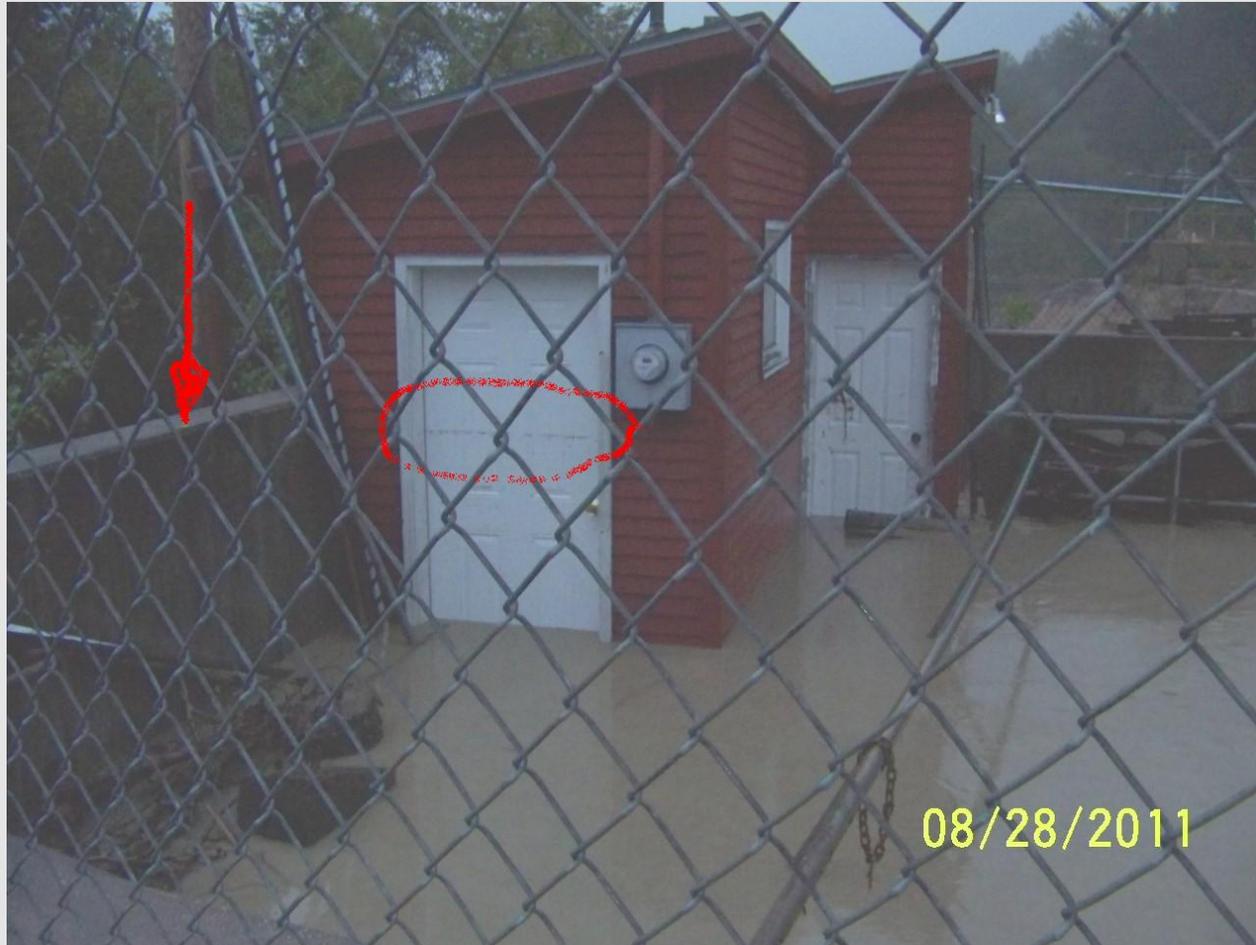
# Campton Dam, 7" Below Spillway Abutments at Height of Flow

- Peak flow = approximately **14,420 cfs**
- Peak impoundment level: 7” below the top of the dam.

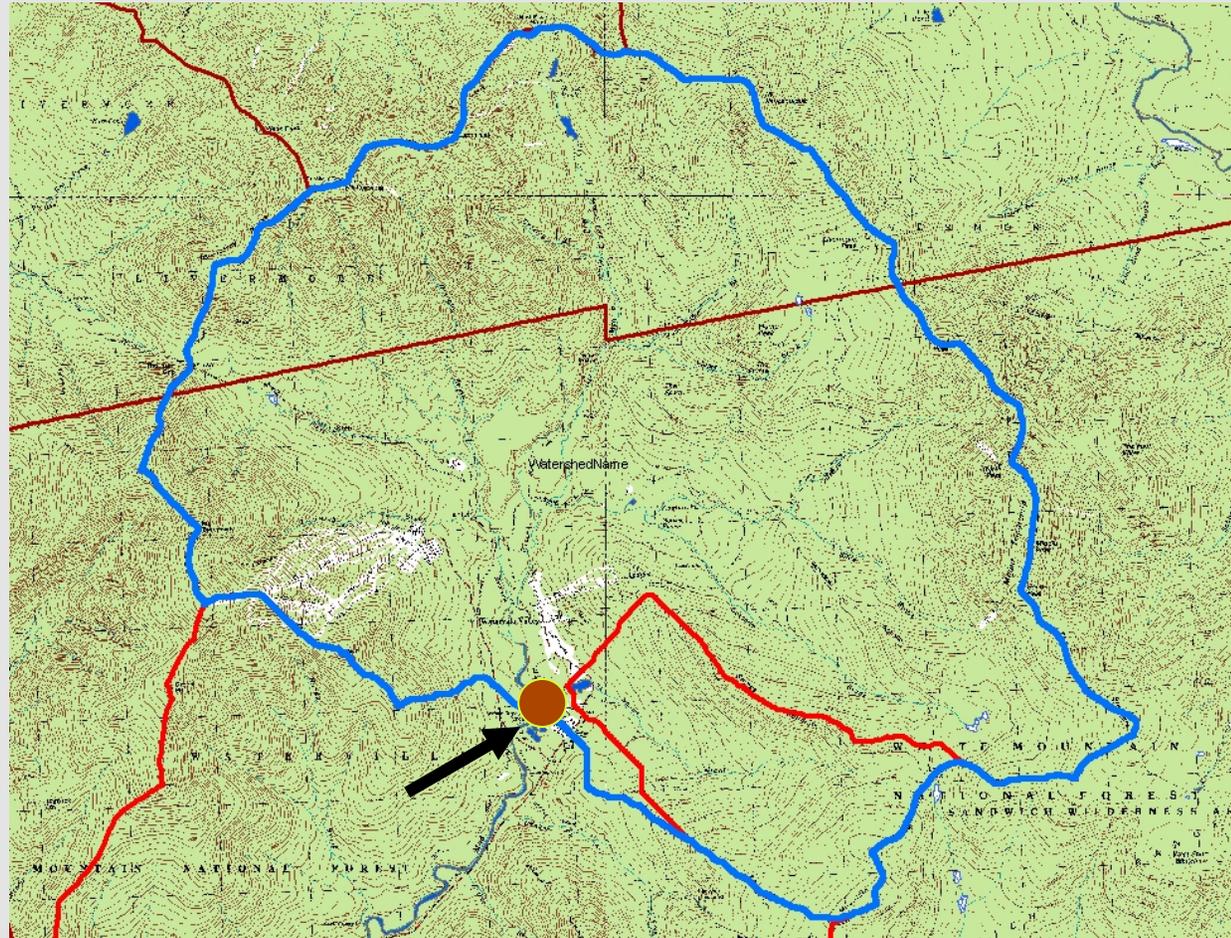
# Upper Portion of the Campton Pond Dam Watershed

Junction of Snow's Pond Brook with Mad River  
15,760 acres above junction (43% of Campton  
Pond Dam's watershed)

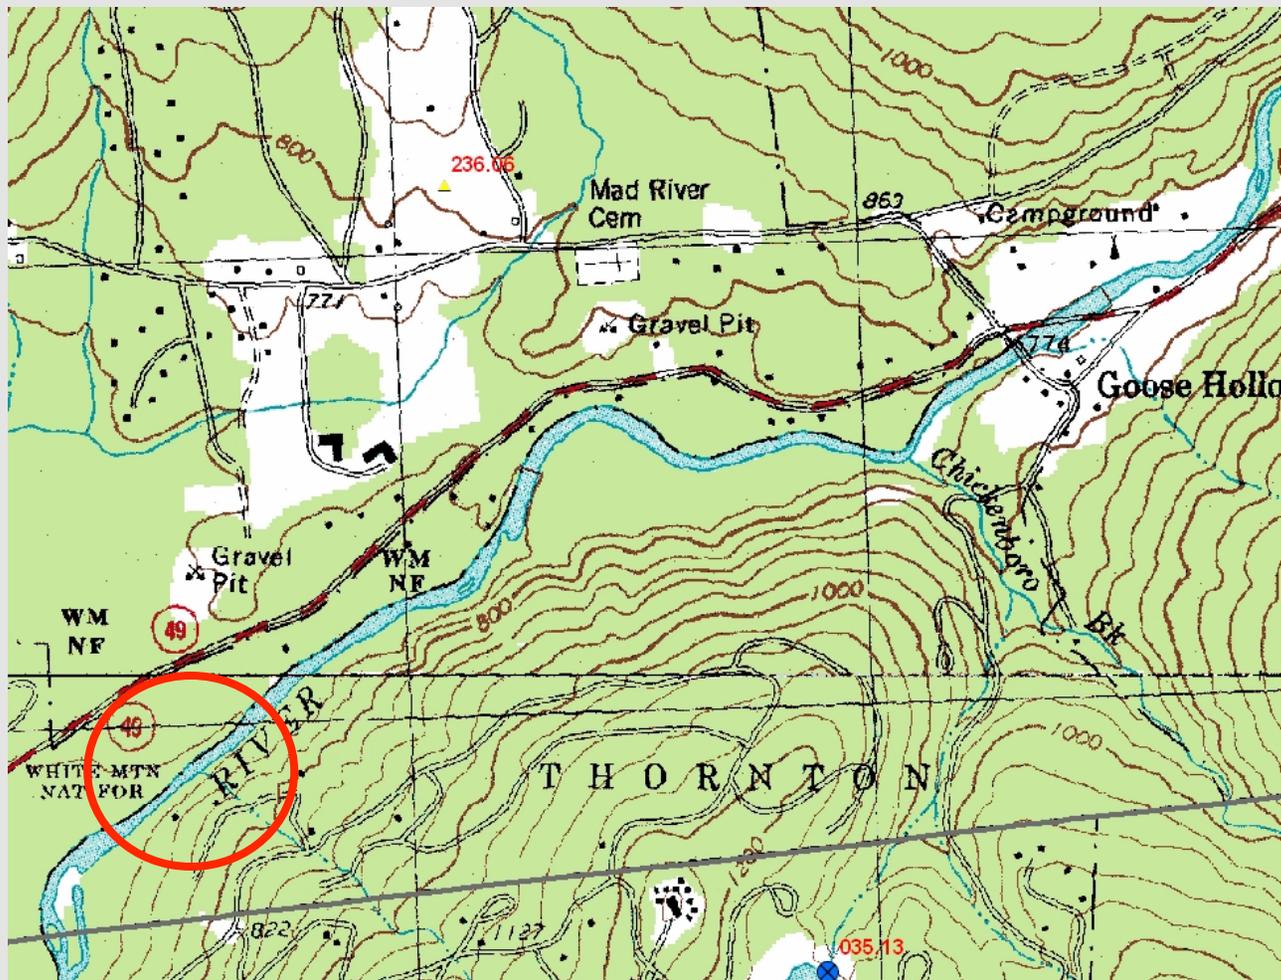
# Mad River Cross Section Survey

- Located on property of Mr. Morton, Rte 49 Thornton NH
- Surveyed October 18<sup>th</sup>, NHDES staff.
- High water marks were identified with Mr. Morton
- Develop calculations showing flow during Tropical Storm Irene that could be compared with flows following the flashboard operation at Snow's Pond Dam.

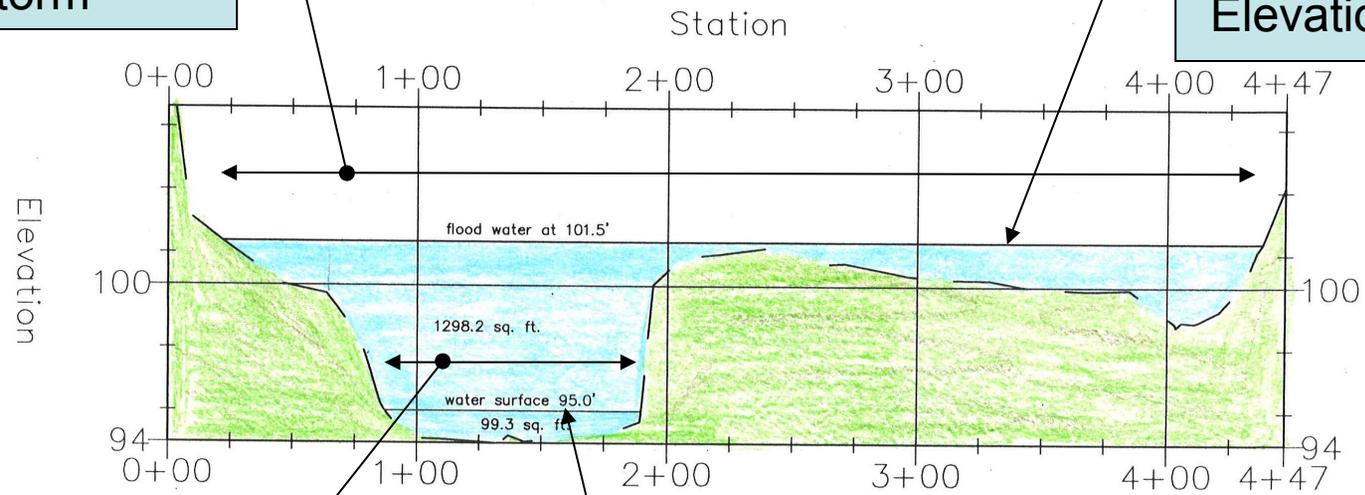
# Mad River Cross Section

Approx 416 foot wide river during storm

8-28-2011  
Elevation 101.5

104 foot wide river normal flow

X-SECTION FOR  
MAD RIVER  
CAMPTON, N.H.  
scale 1"=60'

10-18-2011  
Elevation 95.0

- Flow = **13,267 cfs** (cubic feet per second).
- Velocities = from 1.6 fps to above 13.9 (feet per second).

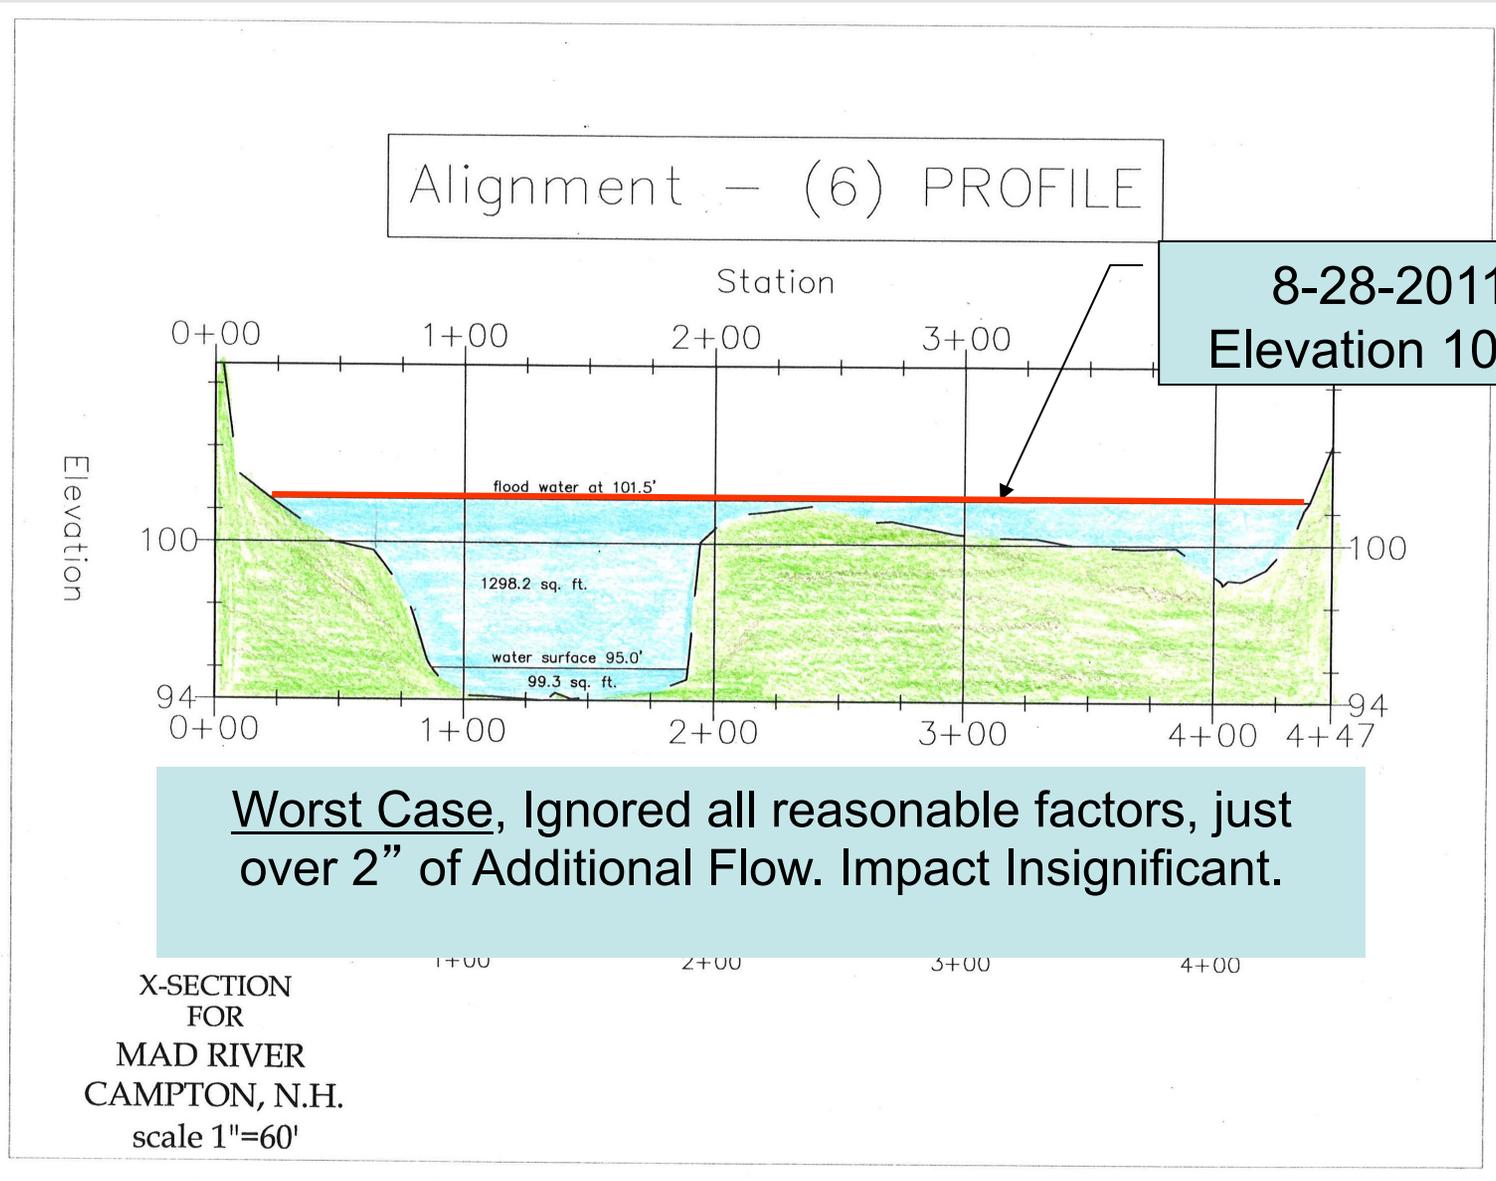
# Conclusions

- Incremental difference to Mad River's elevation at Mr. Morton's property cross section due to operation of Snow's Pond Dam's flashboards, ignoring all reasonable dispersion factors is just over 2".
- Estimated travel time in the Mad River to Mr. Morton's property; travel distance of 9.5 miles = 65 minutes, equals approximately 3:05 arrival time from operation of flashboards at Snow's Pond Dam (approximately 2:00).
